## Case Report

# Commercial Woodchipper Fatality

*Dean A. Beers*  
*Patrick C. Allen*

*Larimer County Coroner's Office*  
*Loveland, CO*

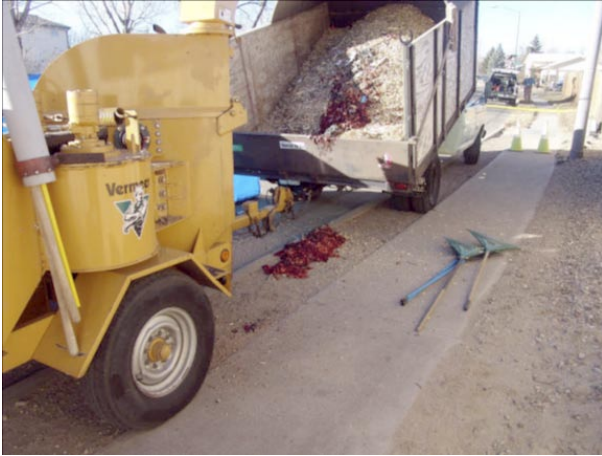
*Figure 1*

Beginning with the remains on the ground between the woodchipper and the product truck (Figure 1), and working from those nearest the woodchipper to nearest the product truck, the remains and associated evidence were photographed, collected, cataloged, and sorted by categories into clothing, property and evidence, remains for identification (e.g., DNA, dental, fingerprints), and then remaining body parts. These bags were individually marked and sealed on scene. The area containing remains on the ground measured approximately 68" by 22" at its widest point.

*The woodchipper and product truck.*

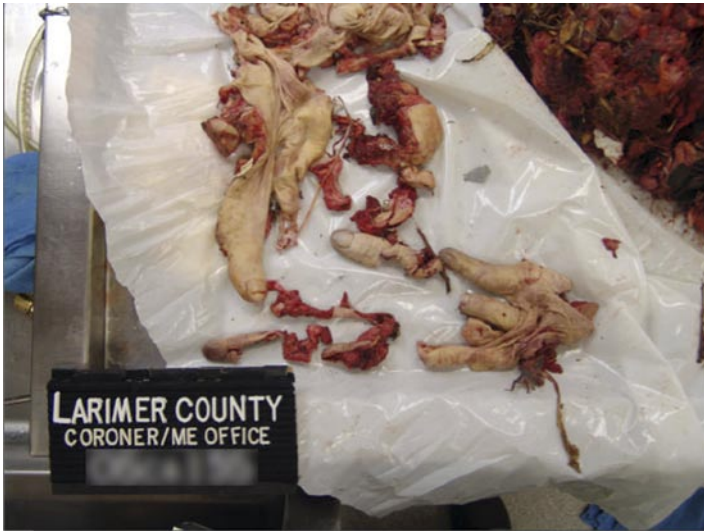
*Figure 2*

The same process was repeated to gather the remains in the product truck, working from the tailgate toward the cab. The area containing the remains in the product truck measured approximately 110" by 22".

*Some of the remains recovered from truck bed.*
